# Manhole Inspection Summary

Manhole # S06YY1003MH

Insp Date: **6/21/06 8:00 AM**

**Location** Address: **3924 CLARINTH AVE**

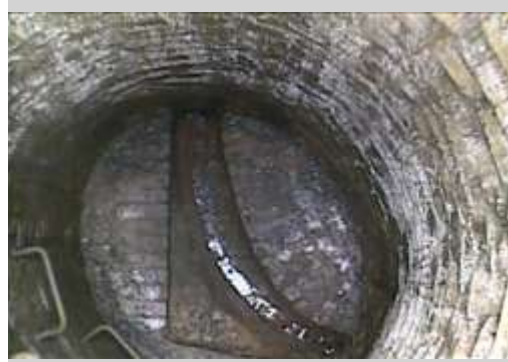
Top View

Adjustment and Corbel infiltration. Bench debris.

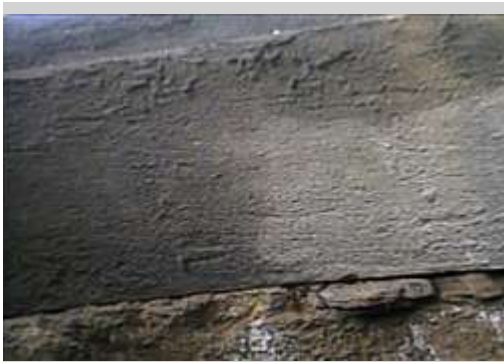
Defect

Frame leaks. Adjustment deterioration and infiltration.

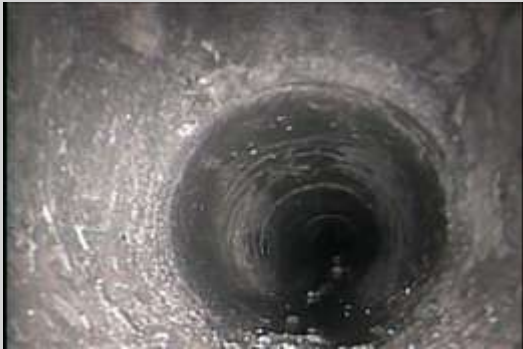
### 8 in. Circular Gravity Sewer Pipe Out @ 12 O'Clock

Deposits: ☐ None ☐ Mud ☐ Sludge ☒ **Debris** ☐ Grease

Silt Depth: **0** (in.) Deposits Extent: **Light**
